W3AI

R F Hill Amateur Radio Club 2024

Kenwood TS-830S Repair

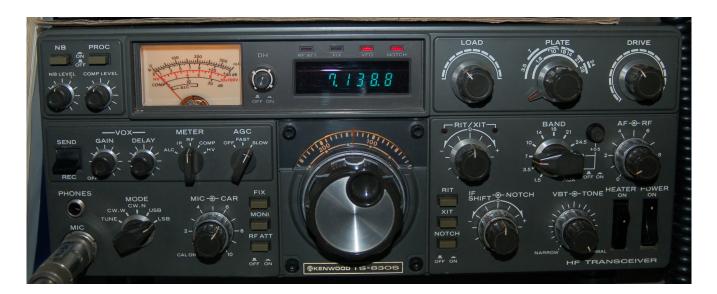
In this one case for my TS-830S, it had several common issues (previously fixed) and now the receive was intermittently low level occasionally after transmit. Transmit was fine.

If I tapped on the RL-1 relay, the received signal would clear up sometimes. See pictures. This switches the final bias, RIT, XIT, exciter gain. Removing the cover on the relay and cleaning the contacts did not fix it. In receive, the contacts would make solid contact only occasionally. This relay, of course, is no longer made (Omron brand) and the Kenwood replacement part is no longer available. A web site for hard to find Kenwood parts makes a replacement that is plug and play. The site is https://www.k4eaa.com.

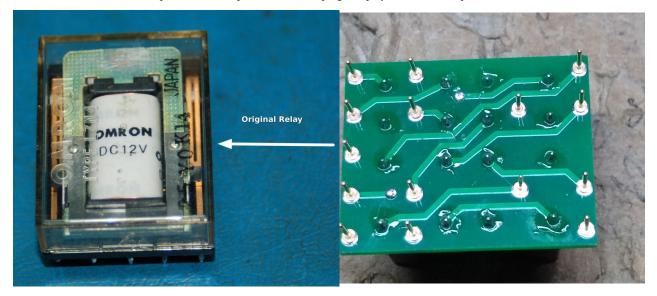
So, I bought the replacement relay board and it came quickly. It consists of two Axicon relays on a PC board. The relays are plugged into sockets for easy replacement (see picture). The Kenwood board that the relay is mounted on is the AF board on the bottom side of the 830S. The AF board must be removed to replace the relay, which is relatively easy. This is just a matter of unplugging connectors and removing the mounting screws for the board. Then the original relay needs to be un-soldered and the new relay board re-soldered in the same holes. You can't get it backwards because the pins only allow mounting it one way.

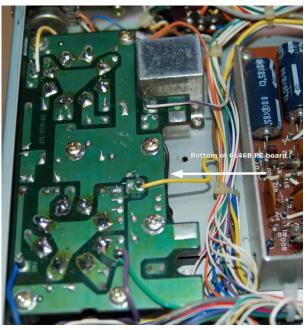
Bottom of 6146B PC Board showing reflowed terminals

Also, while I had the cover off, I checked the PC board that has the 6146B tube sockets mounted on them (see picture). They often will have broken solder joints on the tube socket pins and mine did. They were re-soldered and board was cleaned.

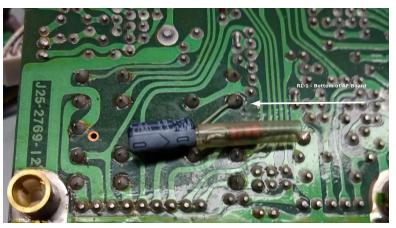
AF Board Location

RL-1 Terminals Viewed from the bottom side of the AF Board
